**Gypsum in Minoan Architecture: Exploitation,
Utilisation and Weathering of a Prestige Stone**

Vol.I: Text

STEPHANIA CHLOUVERAKI

Institute of Archaeology

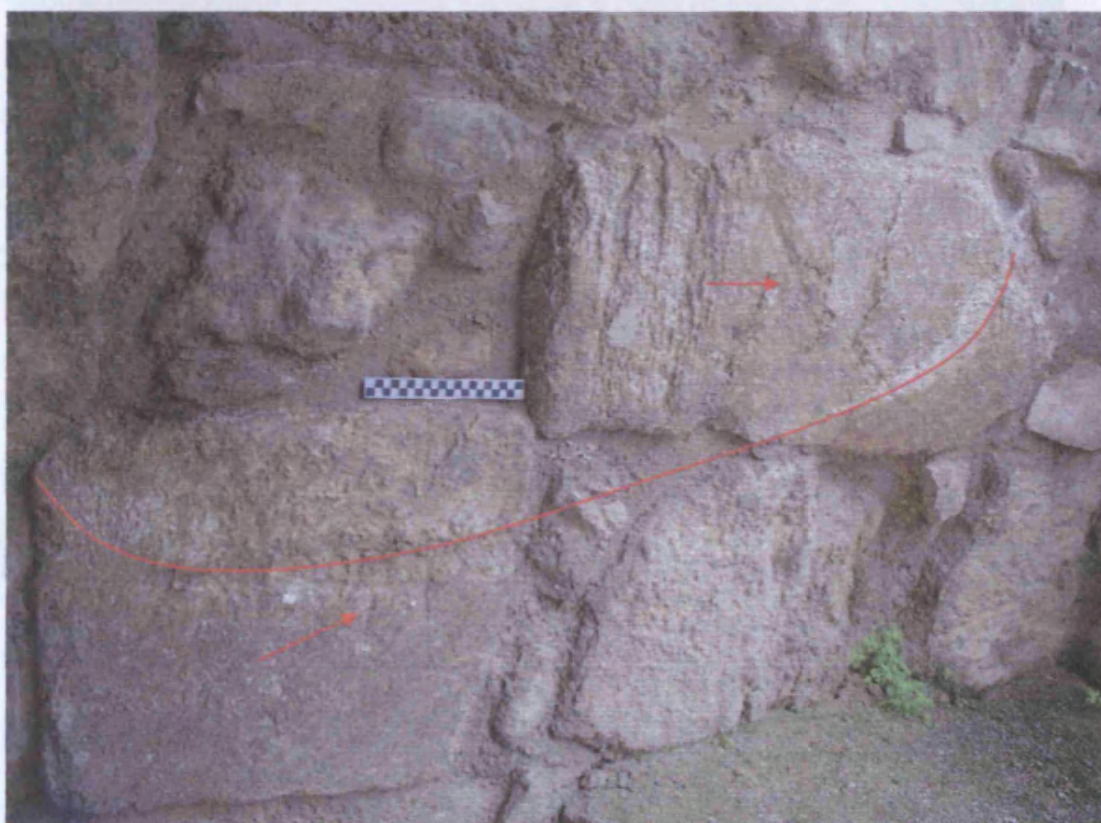
Fig. 5.28: selenite blocks with *cross paté* mason's marks partly affected by fire

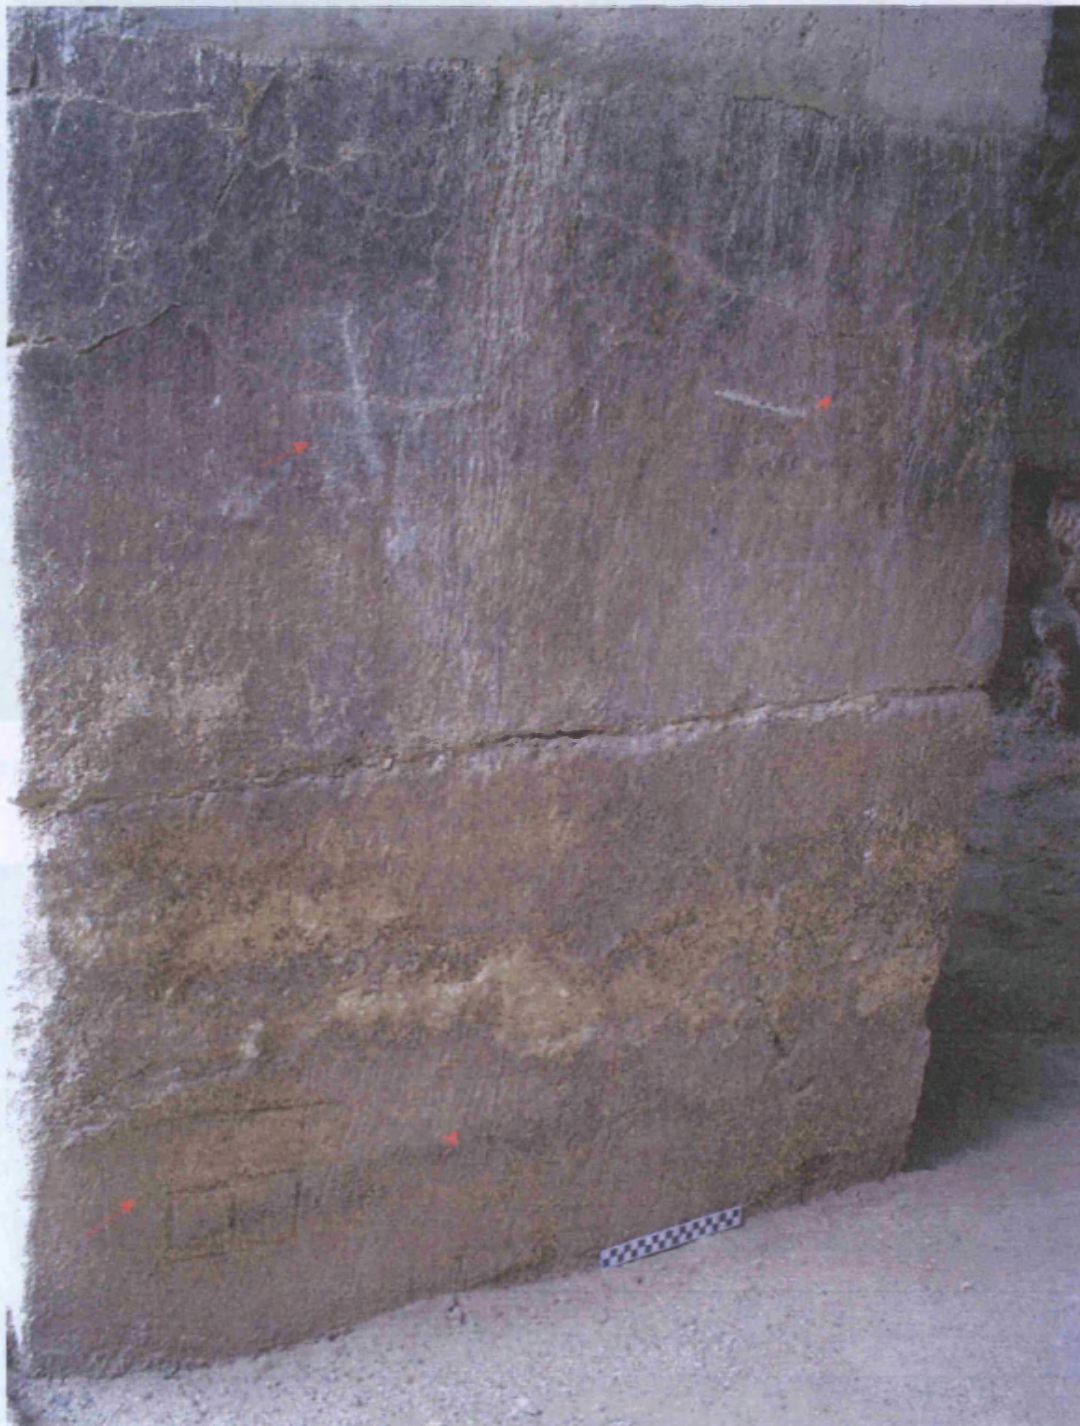
Fig. 5.29: the south jambs of Magazine I (note mason's marks)

The south jamb of Magazine I is the first large jamb in the Corridor of the Stone Jamb (KN1703-1704). Each of the two selenite blocks carries two mason's marks. There are two '*cross paté*' on the upper one and a 'gate' and a 'cross' on the lower. They are both burnt and the upper part is stained black (Fig.5.29). Several selenite blocks in secondary use are built into the south (Fig.5.30) and the north wall (Fig.5.31). The lower part of the blocks is unaffected from fire up to an average height of 50cm while the upper part is burnt. Along the south wall (Fig.5.30) there are two blocks with deeply cut 'cross' mason's marks and tool marks (Fig.5.32-5.33). Along the north wall (Fig.5.31) and close to the entrance there is 'window' mason's mark (Fig.5.34) and a '*cross paté*' on another block towards the end of the corridor. The latter also is marked by interesting broad tool marks. On the west wall of this magazine start the orthostates that are set against the whole length of the west wall of the magazines and form the back side of the orthostatic wall of the West Façade. The orthostates are very similar to those of the West Façade. They have the same height (about 1.10m) but not the same width. The crystals of stone are placed mostly vertically. The first orthostate as well as part of the second are visible on the west wall of this magazine. They are set on a *krepidoma* of which the first stone is a selenite block that is totally unaffected by fire. They also are mostly unaffected by fire except for a small area on their upper part. The second orthostate (the northern) has a large and quite well finished 'double axe' mason's mark (Fig.5.30). It is a common observation in the magazine corridors and the Long Corridor of the Magazines that the lower part of selenite blocks remains unaffected. It seems possible that the lower part of these walls was still covered by wall plaster remains at the time of the last conflagration. Presumably the upper part of the wall plaster detached

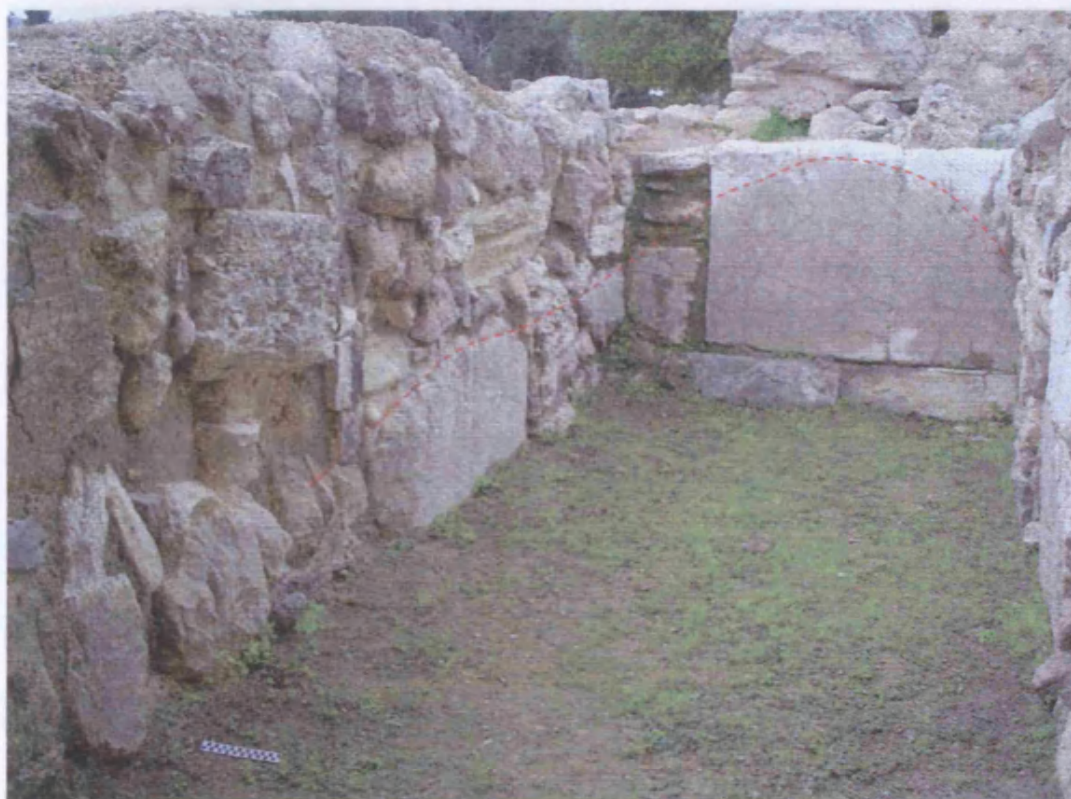
Fig. 5.30: unaffected selenite blocks and orthostates built into the south and west wall of Magazine I, transition line of affected/unaffected by fire

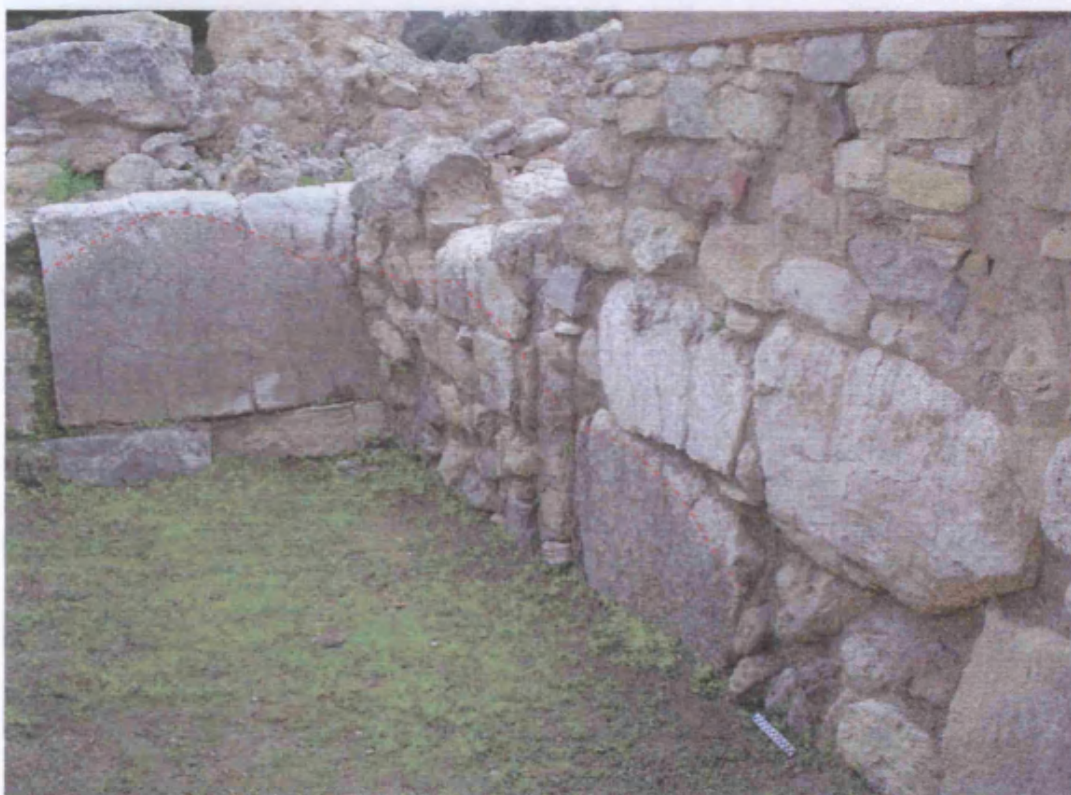
Fig. 5.31: selenite blocks and orthostates built into the north and the west wall of Magazine I, transition line of affected/unaffected by fire

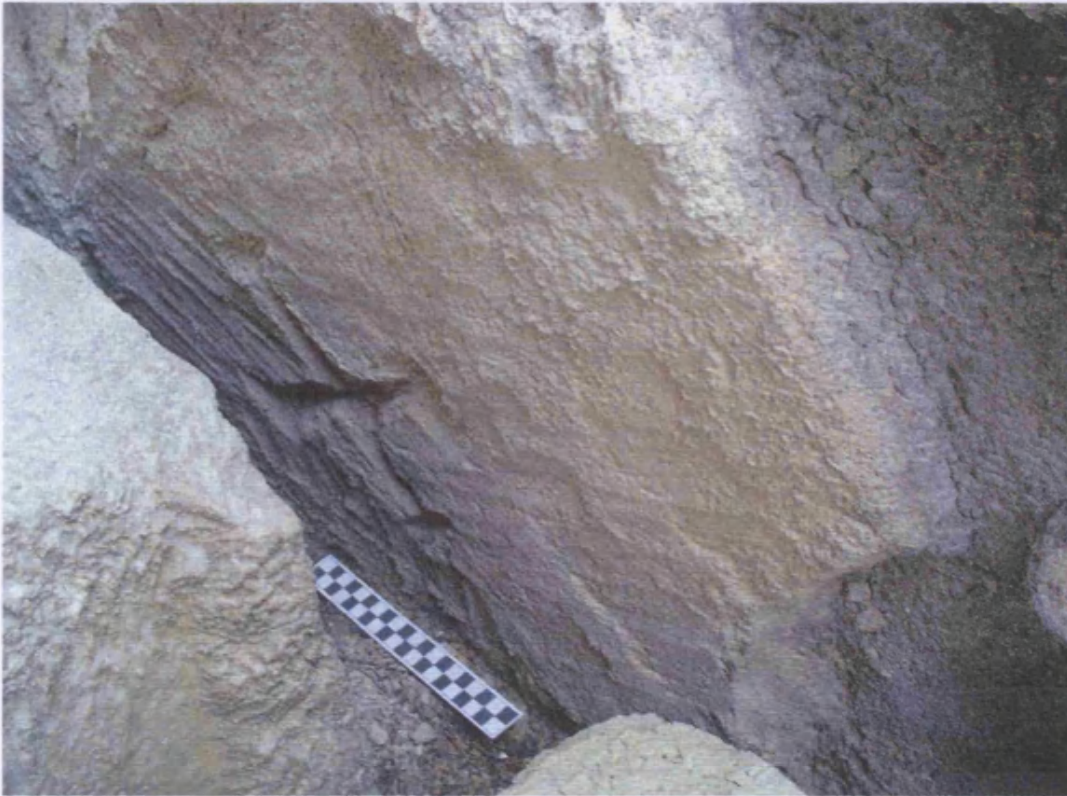
Fig. 5.32: *cross paté* mason's mark and tool marks on a selenite block built into the south wall of Magazine I

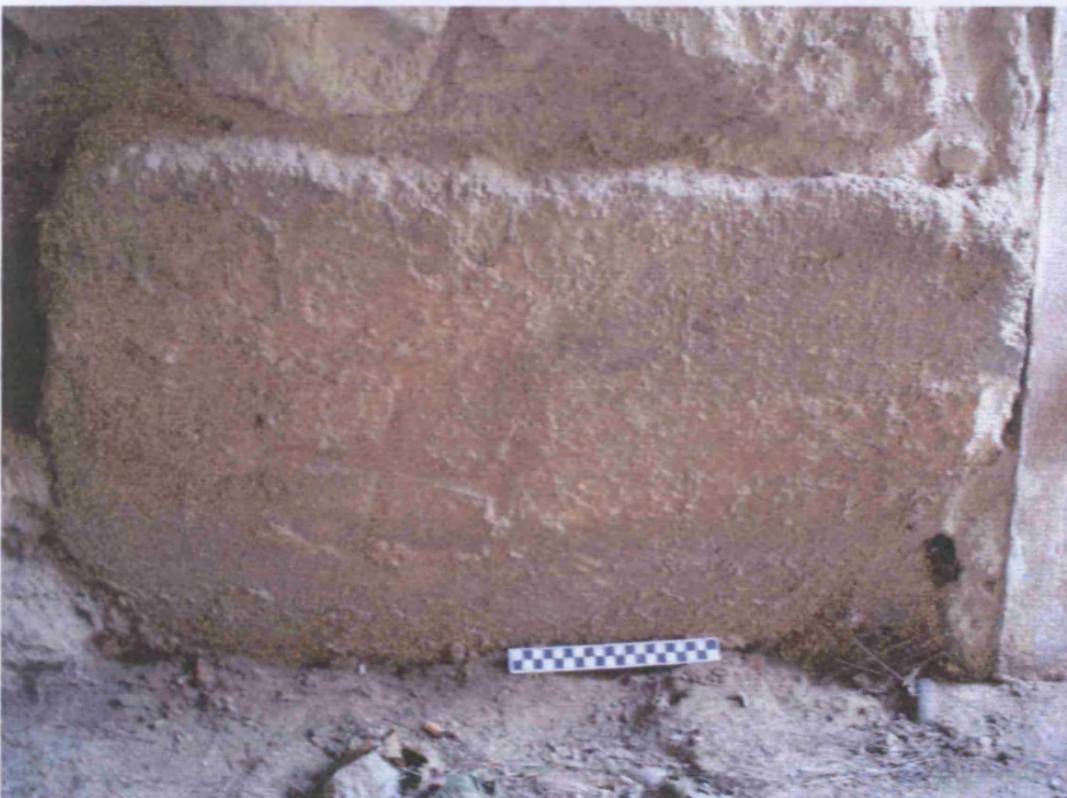
Fig. 5.33: *cross paté* mason's mark on selenite block built into the south wall of Magazine I

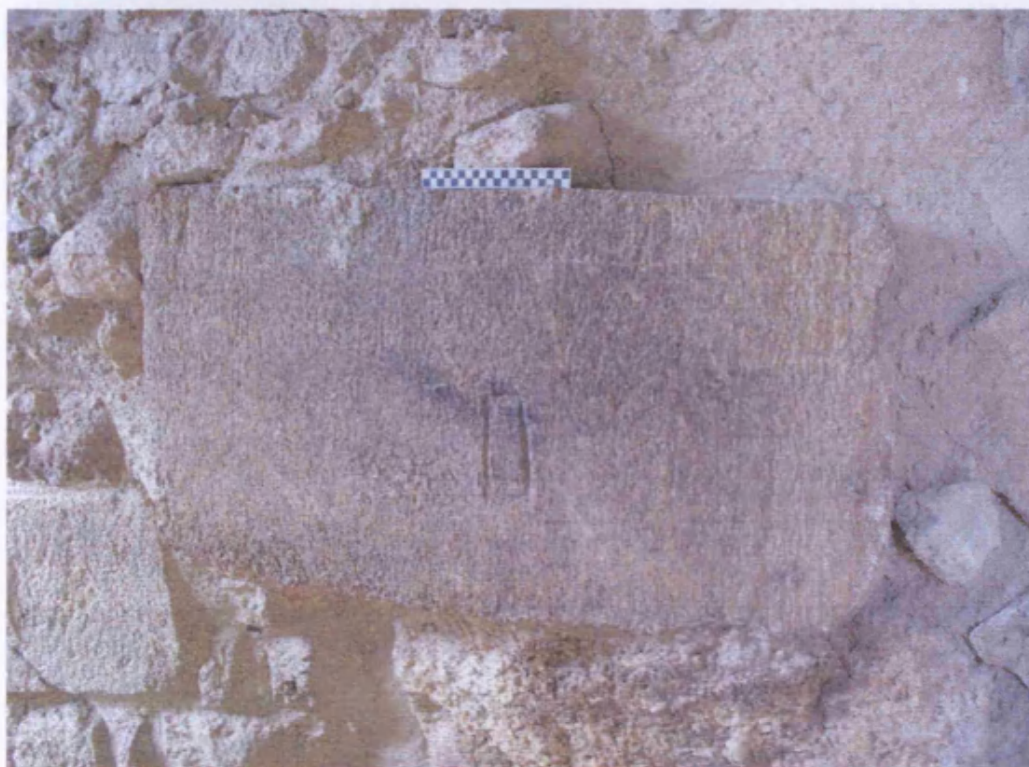
Fig. 5.34: window mason's mark on selenite block built into the north wall of Magazine I near the entrance (east end of wall)

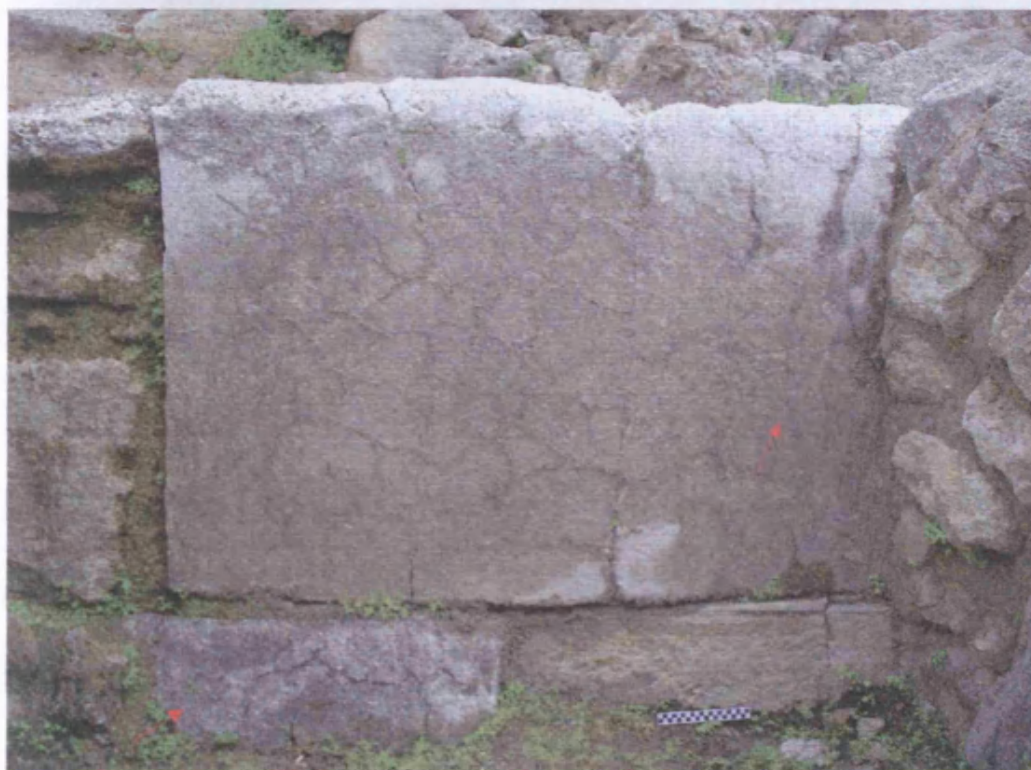
Fig. 5.35: selenite orthostates set against the wall of Magazine I (note double axe mason's mark and unaffected selenite block of the *krepidoma*)

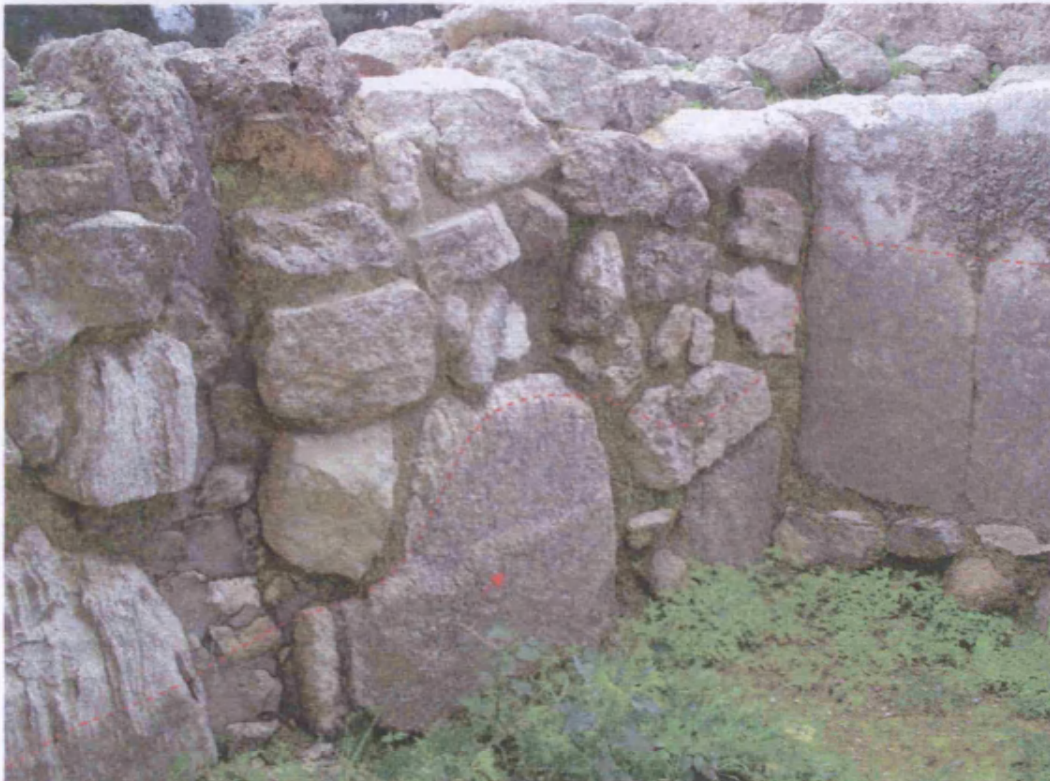
Fig. 5.37: transition line on selenite blocks of the south and the north wall of Magazine II, also note partly preserved '*cross paté*' mark

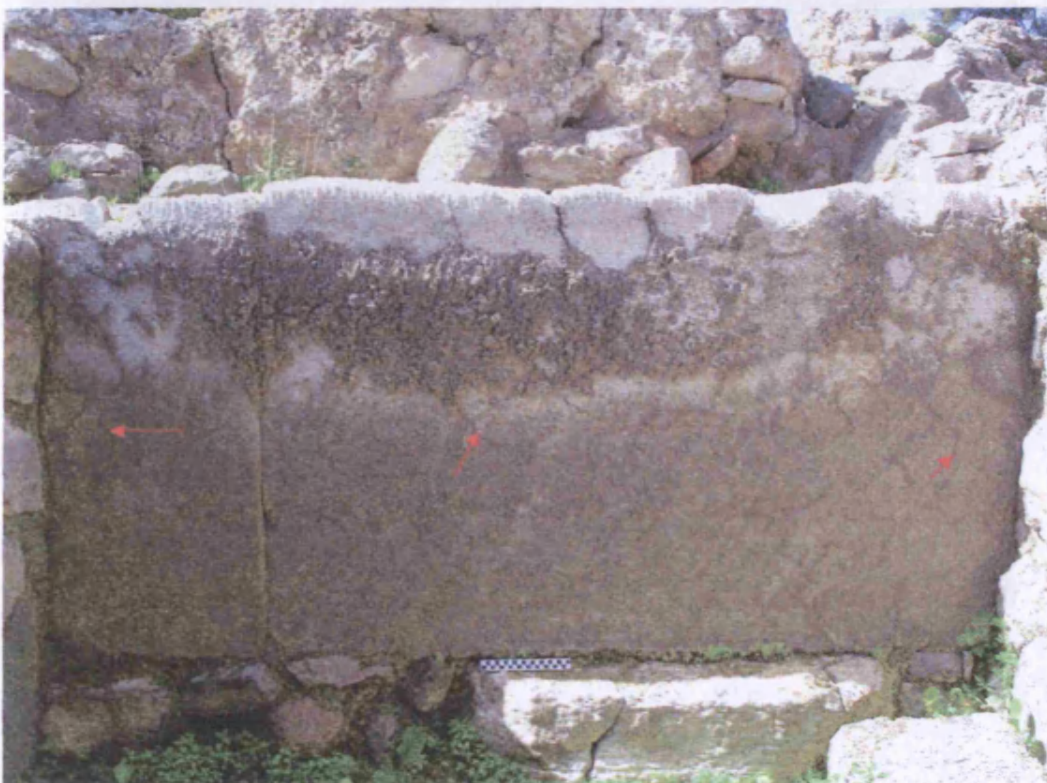
Fig. 5.38: the orthostates set against the west wall of Magazine II (note double axe mason's marks)

The selenite blocks of the second magazine (*KN1701-1702*) carry the following mason's marks: a deeply cut 'gate' and a more lightly curved 'cross' on the lower and another deeply cut 'gate' mark on the upper. The weathering of these blocks is very similar to that of the first jambs. They are totally burnt and the upper part is also stained black (Fig.5.36). The south and the north wall of the second magazine are also very similar to those of the first corridor that was described above. Various reused selenite blocks are built into to both walls which at the lower part of the wall are mostly unaffected by fire. Tool marks and one 'cross' mason's mark are preserved on the surfaces of some blocks (Fig.5.37). The orthostates that are set against the west wall of the magazine and they present quite interesting and characteristic fire marks and weathering forms. They both have double axe mason's marks and it is mostly interesting that the north and the south wall are built against them and cover their edges (Fig.5.38).

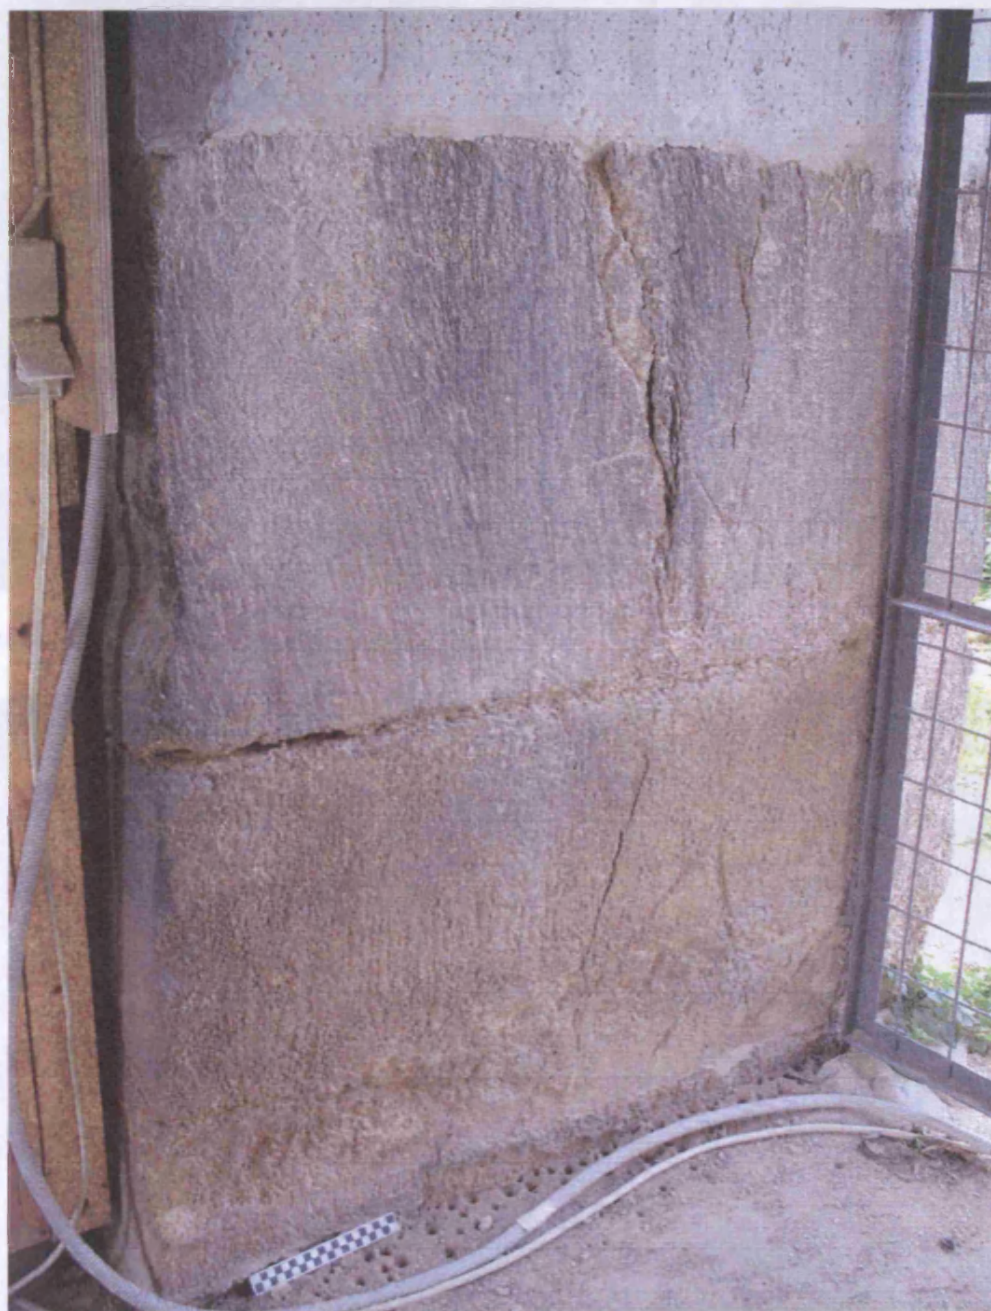
Fig. 5.39: the south jambs of Magazine III

only on the upper part and are similar to those that were described above (Fig.5.39). Selenite blocks in secondary use are found again on both south and north walls of the magazine (Fig.5.40). Various tool marks can be seen on the surfaces of these blocks and on the sides of the jambs of the entrance. A 'window' mason's mark is also found on a block towards the end of the south wall and two deeply cut 'double axes' without stem are found on the north wall towards the entrance (Fig.5.41). Two selenite orthostates are set against the end of the south wall and another two against the west wall (Fig.5.42). The transition line between affected and unaffected stone is just a few centimetres above the base of the orthostates and continues from one to the other suggesting that almost the entire room in that side was in fire at least once in the history of the building. Evans has marked two 'double axe' mason's marks that can barely be seen today (Evans 1921:449, Fig.322). Remains of both lime stone and gypsum slabs are apparent on the floor of this corridor in contrast to the previous one where there are no visible remains of paving (Fig.5.43). The remains of the gypsum slabs are embedded into concrete, burned and stained black. The rest of the floor is reconstructed with concrete that is divided into rectangular slabs imitating the original floor pavement. The surface of gypsum remains is about 2cm lower than the surface of the concrete around it suggesting that it has dissolved down to this level since Evans' restoration campaign in 1929 or the later conservation and restoration campaigns of N. Platon.

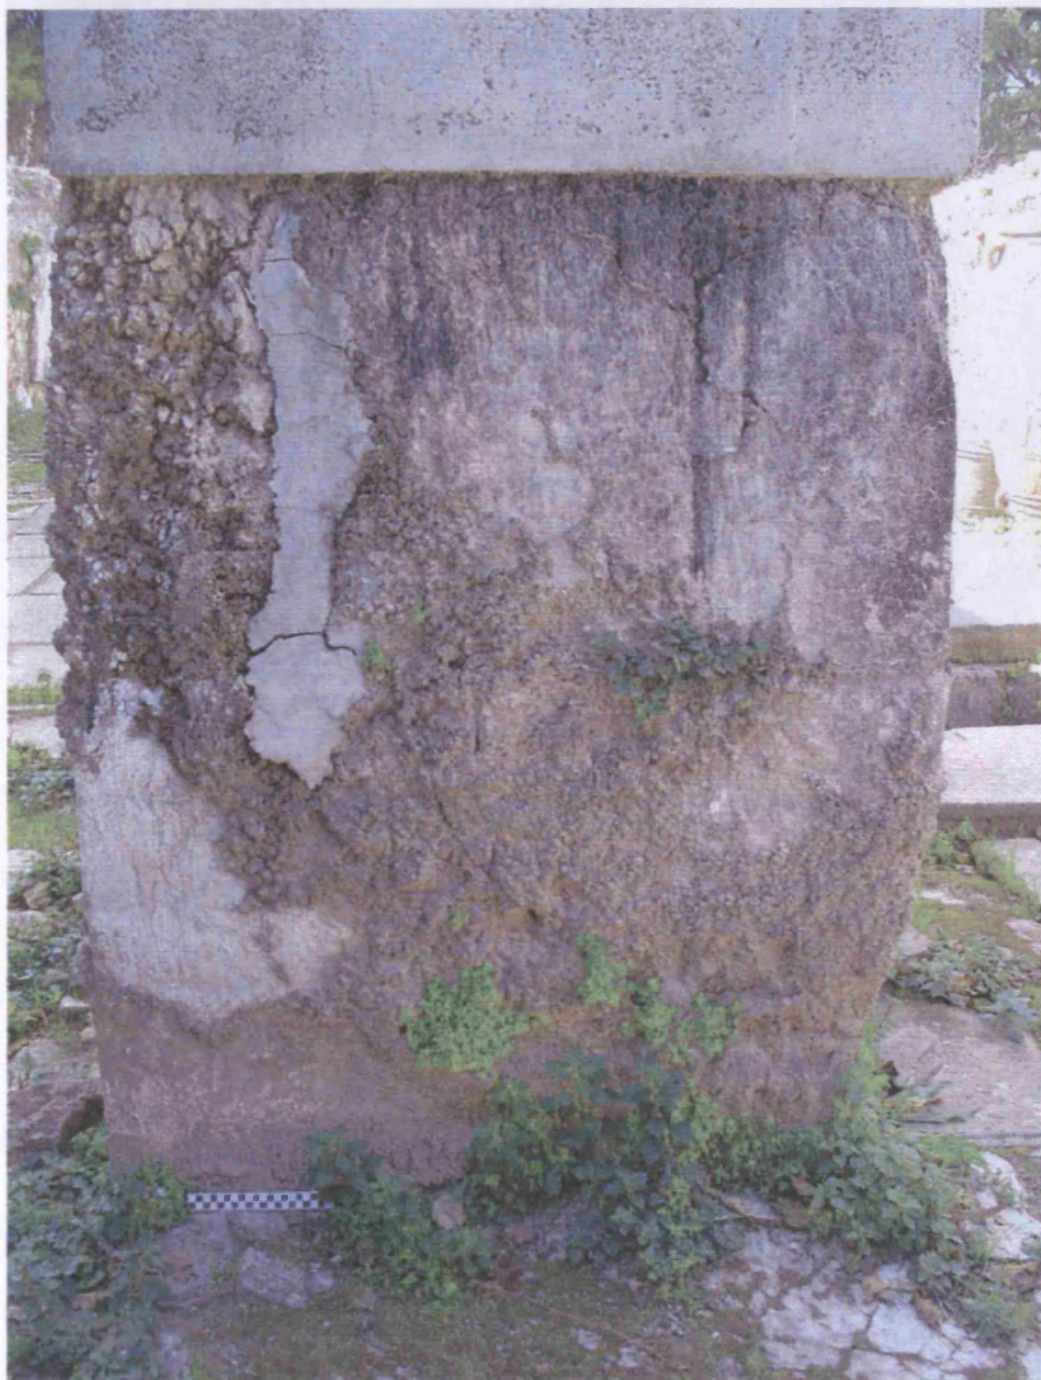
Fig. 5.44: the north orthostate of Magazine IV, exposed to outdoors environment

The south jamb of the fourth magazine (KN1697-1698) is exposed to an outdoor environment and therefore is not as well preserved as the ones that are described above. The lower part that is unaffected by fire is in a relatively good condition while the rest of it is poorly preserved due to the action of rain water (Fig.5.44). There is a 'double

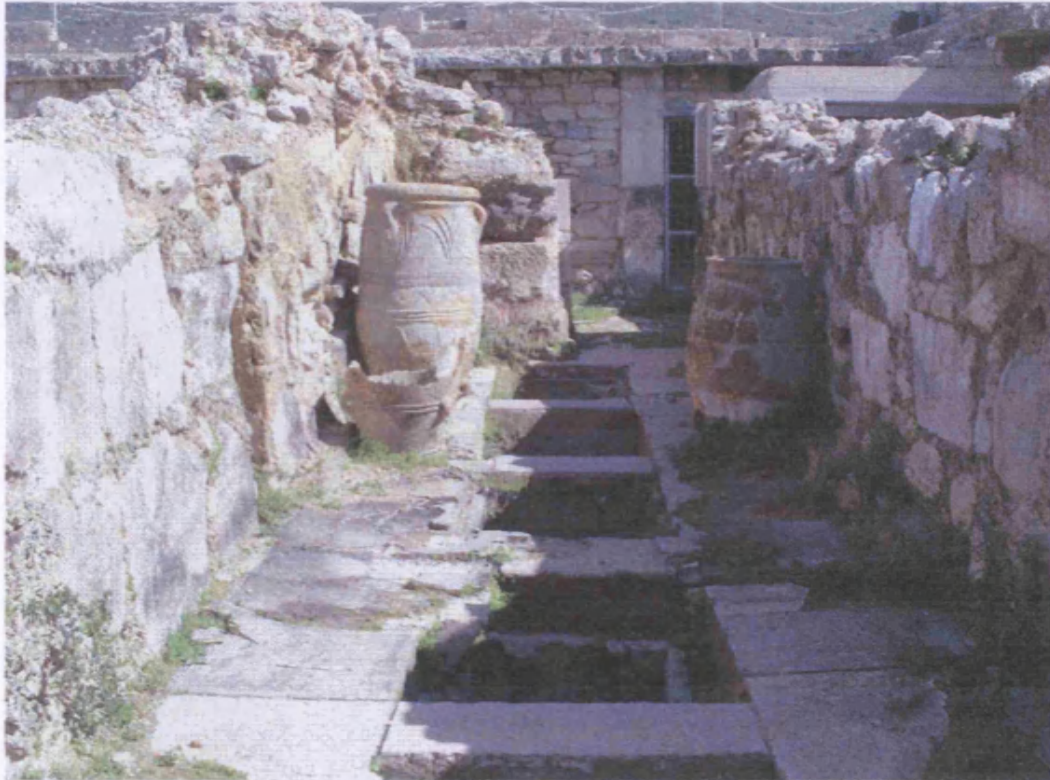
Fig. 5.47: black staining of the floor slabs and the walls in magazine IV

Fig. 5.47: black staining of the floor slabs and the walls in magazine IV

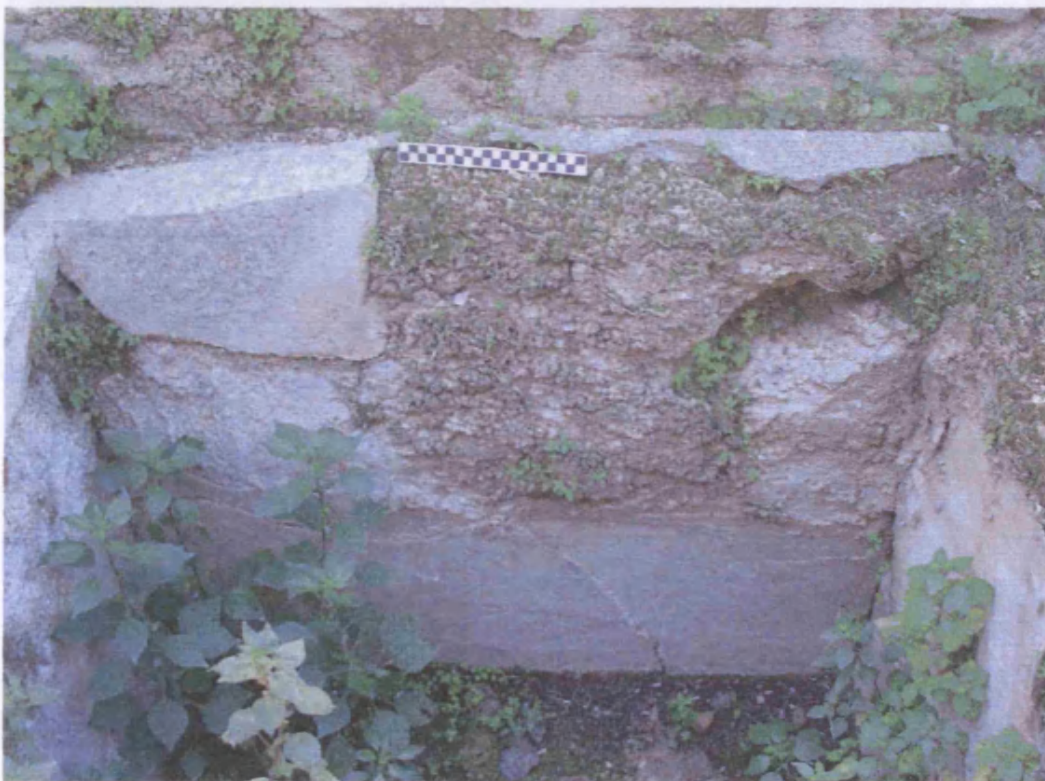
Fig. 5.48: cist lining, note difference between preservation of upper (affected by fire) and lower (unaffected by fire) parts

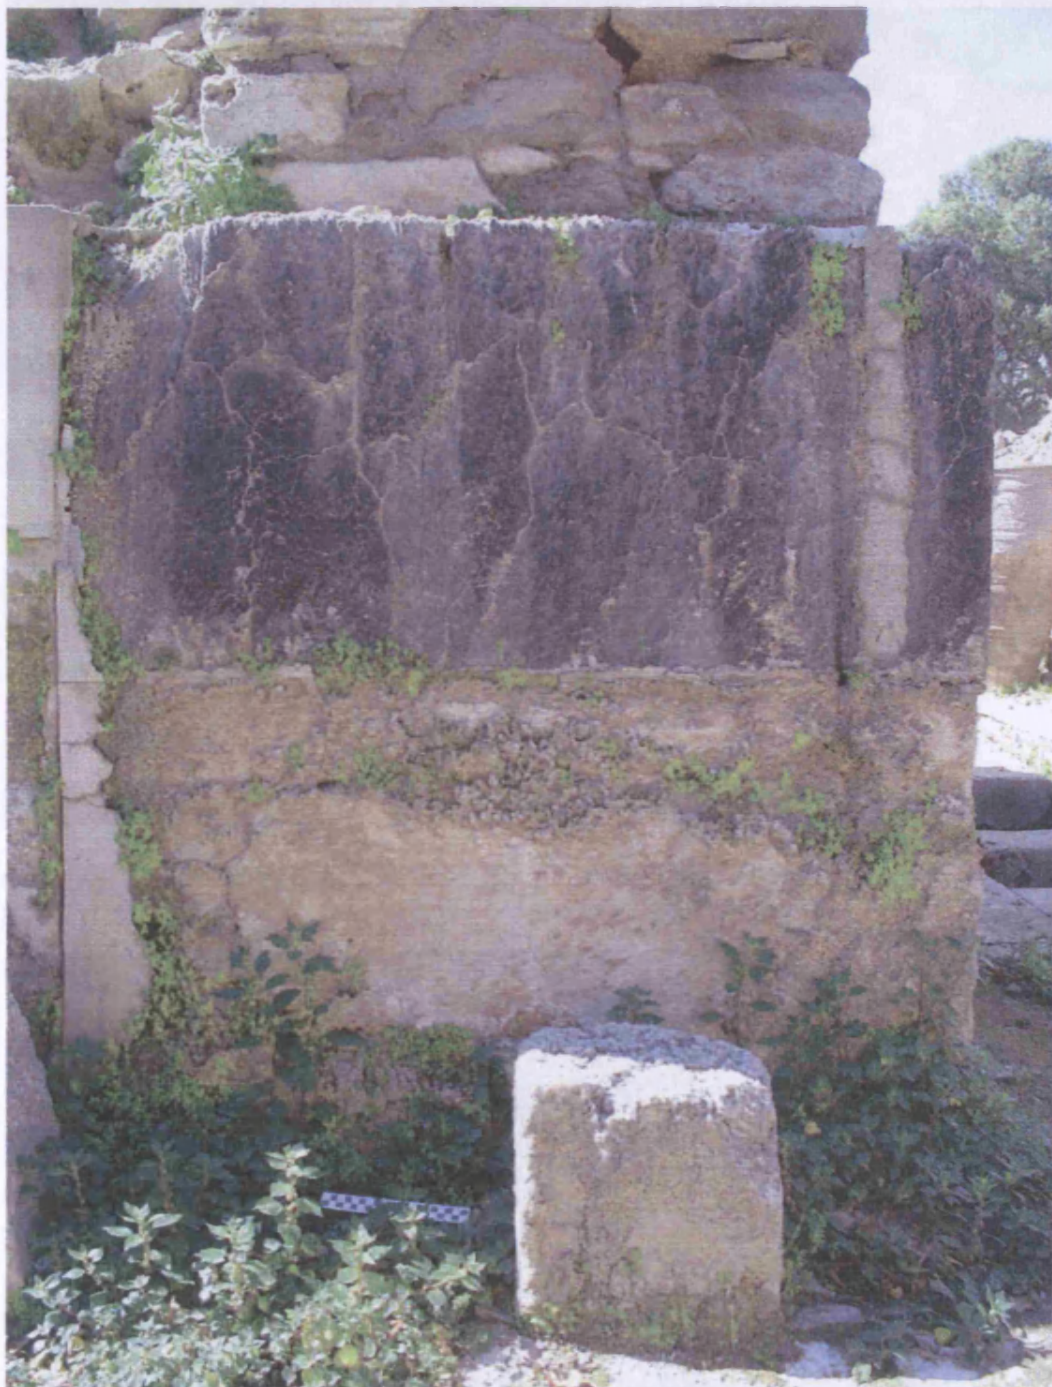
Fig. 5.49: the south orthostate of Magazine V

The south jamb of this magazine (KN1695-1696) is also as heavily weathered as the one described above in Magazine IV (Fig.5.49). There are no visible mason's marks and the upper block is stained black (Fig.5.50). The entrance of the magazine was narrowed by the later addition of a wall and a new limestone L-shaped doorjamb base. Along both south and north walls are various selenite blocks in secondary use that are all burnt and heavily weathered. There are six cists along the floor of the magazine and one is built in the south wall. The cists are all lined with selenite slabs that are all burnt and only partly preserved. The cist of the south wall is built with selenite blocks rather than slabs (Fig.5.51). The selenite blocks of the cist are burnt and although their outer surface is incised by dissolution flutes, the surface of the interior that is protected from the rain water is well preserved. A 'double axe' mason's marks are curved on either side in the interior of the cist (Fig.5.52). The orthostates of the west wall are made of vertical selenite with large crystals up to 4-5cm and are only partly affected by fire (Fig.5.53). They show interesting weathering pattern quite similar to that of the orthostates in Magazine II (Fig.5.38). Evans has reported one double axe mark in front of the west wall that is hardly visible today. The floor was originally paved with gypsum slabs of which there are only a few remains while the rest is restored in concrete. The original remains of the slabs are made of selenite part of which, under the pithos at the south

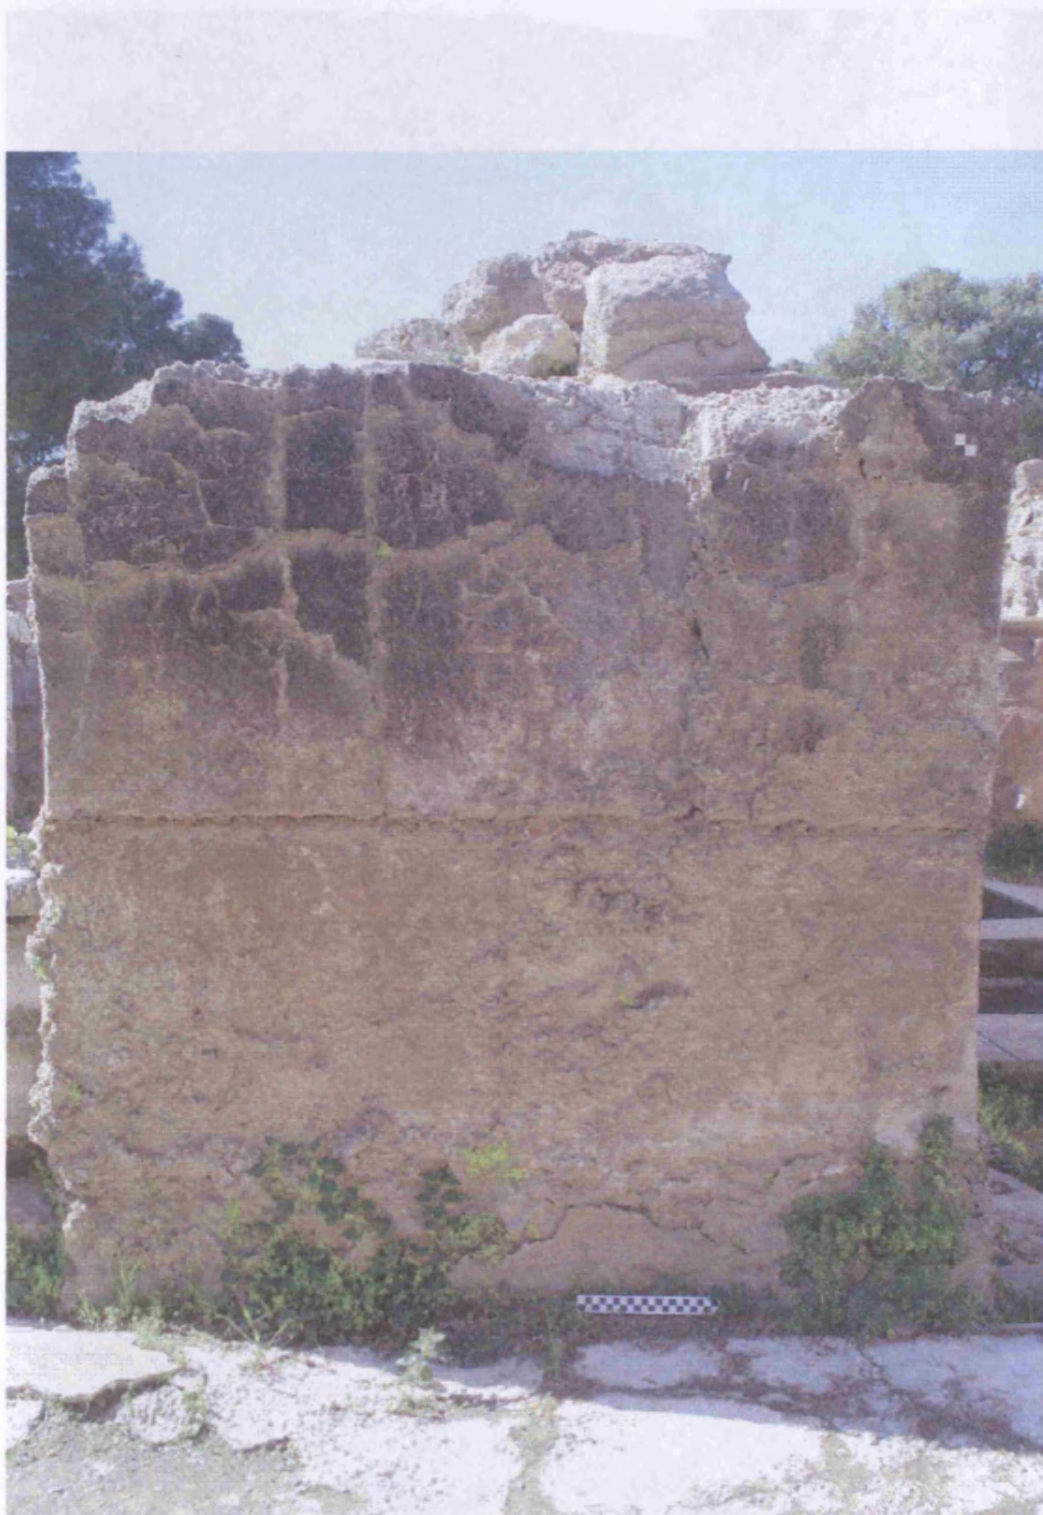
Fig. 5.54: the south jamb of Magazine VI

As in the previous magazines, the south jamb of the sixth magazine (*KN1693-1694*) is heavily weathered due to dissolution and the upper block is stained black (Fig.5.54). There is a double axe mason's mark preserved on the surface of the upper block. Several selenite blocks are built into the south and the north wall, one of which in the south wall has another 'double axe' mason's mark (without stem). They are all burnt and heavily weathered (Fig.5.55). At the west end of the south wall there is an orthostate that corresponds to the side of the second projection of the West Façade. In Evan's plan a double axe is again indicated in front of the orthostate that I have not been able to locate (Evans 1921:449, Fig.322). The lower part of the south orthostate is unaffected by fire and the transition line between affected/unaffected stone continues on the orthostates of the west wall (Fig.5.56). The paving of the floor is mostly reconstructed in concrete. Original fragments of the floor slabs that are embedded in the concrete consist of both selenite and 'nodular and lenticular' gypsum. There are seven cists along the corridor that are also dressed with both selenite and 'nodular and lenticular' gypsum. Characteristic example is the seventh cist in which the north and the south lining slabs are made of selenite while the east and the west are made of 'nodular and lenticular' gypsum (Fig.5.57). The lining of the first is totally stained black, while in the second third and fourth cists the stain is limited at the lower part of the lining (Fig.5.58). The lining of the fifth cist is not stained but is burnt and heavily weathered while the lining of the sixth and the seventh is only partly affected by fire at the top.

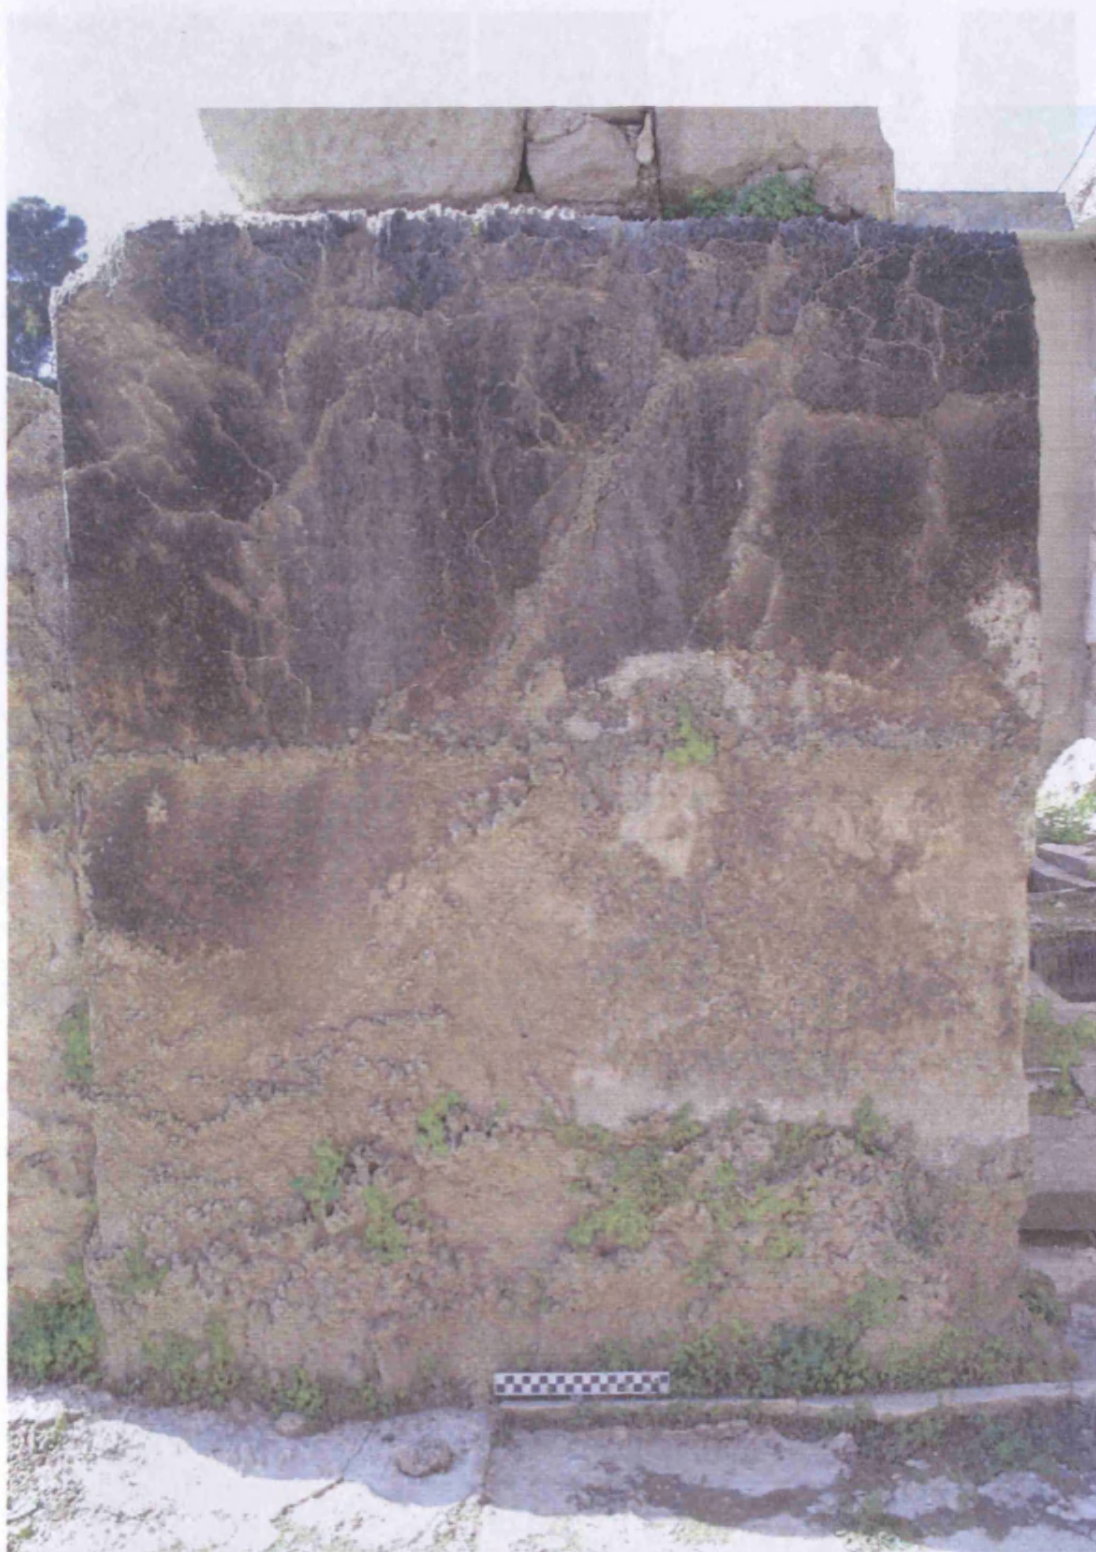
Fig. 5.59: the south jamb of Magazine VII

The south jamb of this magazine is also heavily weathered and stained black (KN1691-1692). A shallow, 'star' mason's mark is only partly preserved on the upper block of the jamb (Fig.5.59). Two L-shaped gypsum doorjamb bases were added to narrow the doorway in the New Palace period or later. They were then paved over by the latest gypsum paving that is partly preserved at the present. The Magazine contains seven floor cists that were probably all lined with gypsum slabs although there are no traces preserved in the fourth and the fifth (Fig.5.60). Both selenite and 'nodular and lenticular' gypsum are used for floor slabs and for the lining of the floor cists which are all affected by fire and stained black in places. The orthostates of the west wall are also burnt and stained (Fig.5.61) as are the reused blocks of selenite of the south and north walls which are heavily weathered and do not preserve any characteristic features apart from a 'double axe' mason's mark that is found on a block to the north jamb of the entrance. A 'double axe' mark is also pointed out by Evans in the same plan that was mentioned above (Evans 1921:449, Fig.322). In this area there is also very interesting evidence of conflagration in different chronological phases that demonstrates the potential of a systematic mapping of fire marks on architectural gypsum with respect to the different building phases (Fig.5.62). It seems that at the time that the L-shaped doorjambs were close to fire the side of the north large jamb was covered with plaster that prevented its dehydration. The gypsum floor paving that is above these doorjambs was also burned at a later phase but the lower part of the gypsum jambs still remained unaffected, while the upper part is all affected showing clear pseudomorphs of large selenite crystals (Fig.5.63). It is apparent that the wall plaster collapsed during a fire destruction that was associated with earthquake. The lower parts of it remained *in situ*

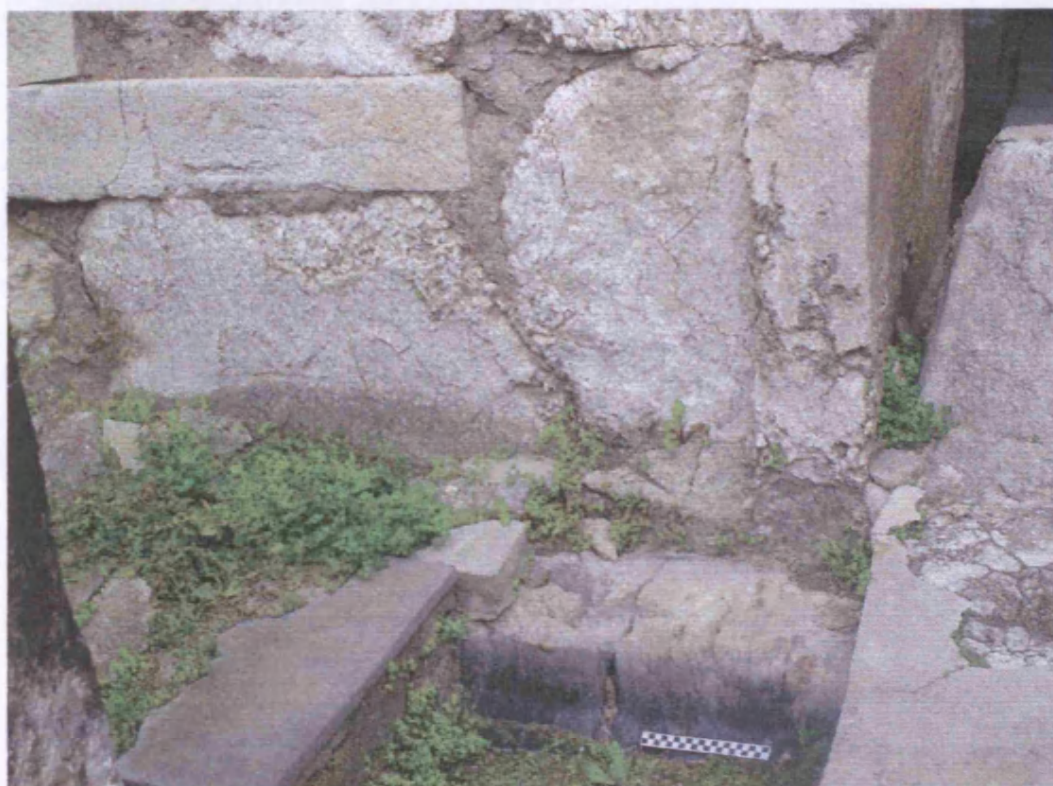
Fig. 5.62: fire marks at the entrance of Magazine VII, note double axe mark on the left block
